## A &amp; R DEPARTMENT NARRATIVE CODE SHEET

#### PART VI - DAMAGE TO THE AIRCRAFT

HS-9 AAR SER 1-62 18 OCT 1962 SH-3A(HSS-2) BUNO 119004, PILOT HUGHES

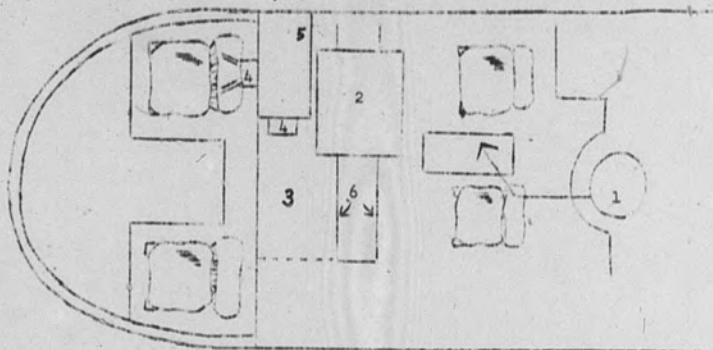
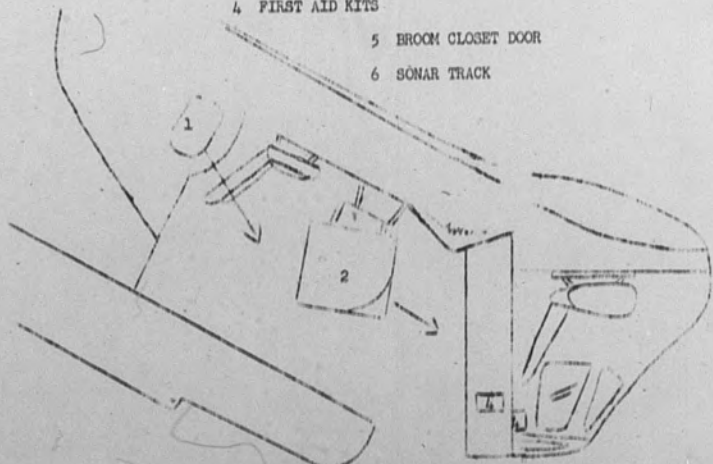
DIAGRAM OF SH3-A HELICOPTER

- 1 SONAR DOME
- 2 SONAR EQUIPMENT
- 3 DECKING RECOVERED WITH FORWARD SONAR TRACK
- 4 FIRST AID KITS
- 5 BROOM CLOSET DOOR
- 6 SONAR TRACK

Although not positively known to have contributed to the crewman's death it is believed that the sensor dome and associated equipment shifted forward upon impact of the aircraft with the water, breaking the crew seats from their moorings and inflicting severe damage. (enclosures (16) and (17)).

4. That force tests be conducted to determine structural failing of the retention points of the seats and seats of the aircraft.
5. Reiterate that pilots and crewman should remain in flotation equipment until rescued by surface craft.

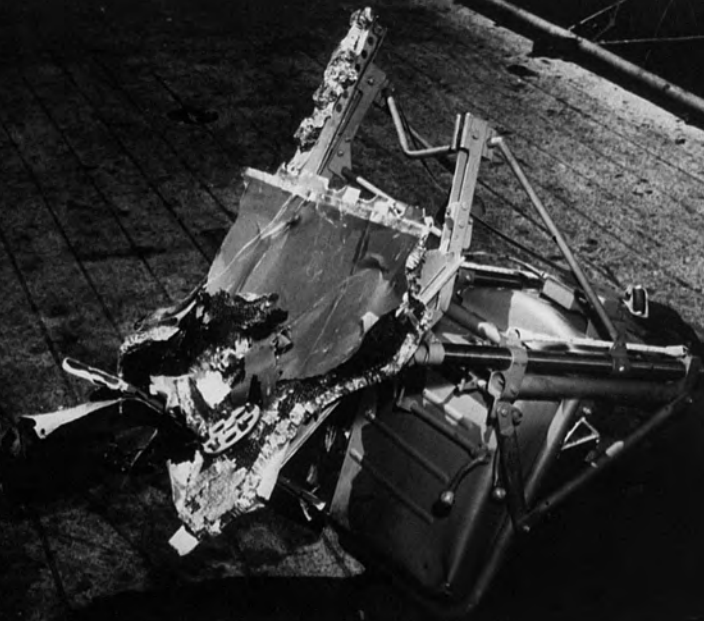
- (1) Starboard sponson and landing gear. Damage: Nose smashed in - inboard tail smashed. Support broken off. Landing gear down and intact.
- (2) Port sponson and landing gear. Damage: Nose smashed all the way back to the first complete bulkhead. Dent in top rear. Landing gear down and intact.
- (3) Seat assembly, Sonar Operator, Left side, Reel locked. Right back support member and seat bent forward (see enclosure (16)).

ENCLOSURE (16) HS-9 AAR 1-62 - LEFT SIDE VIEW, SECOND OPERATOR'S SEAT  
SPECIAL HANDLING REQUIRED IN ACCORDANCE WITH PARA 70, OPNAV INST 0.6D

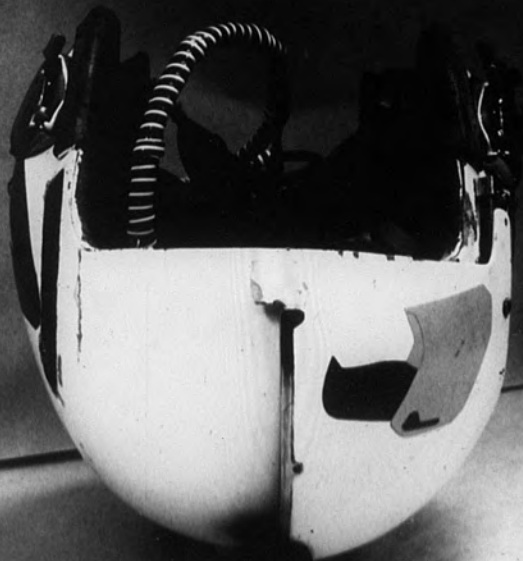
ENCLOSURE (21) HS-9 AAR 1-62 - DAMAGE TO PILOT'S HELMET  
SPECIAL HANDLING REQUIRED IN ACCORDANCE WITH PARA 70, OPHAV INST 3750.6D

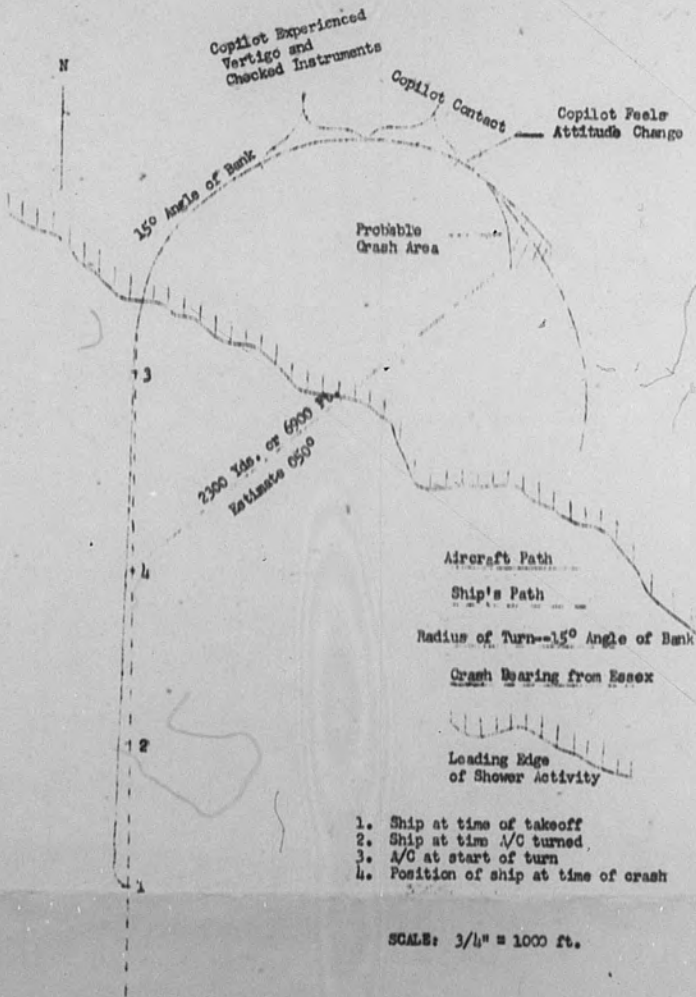
ENCLOSURE (28)

# Diagram of Flight Path

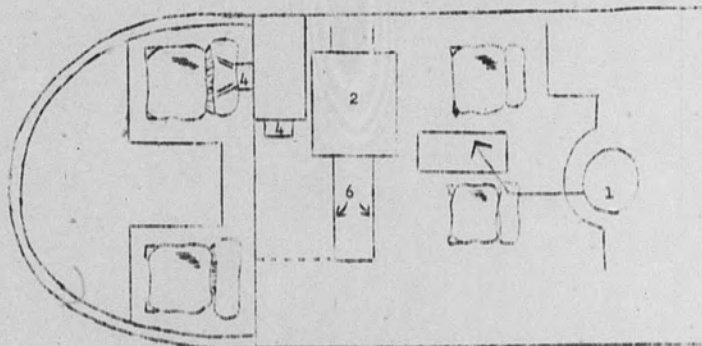
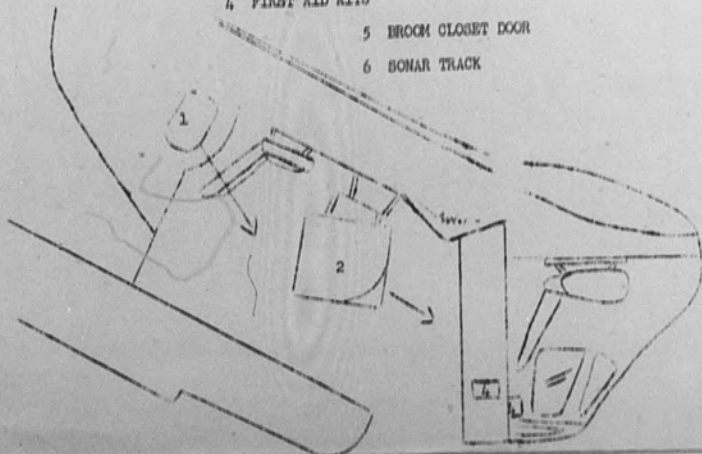
DIAGRAM OF SH3-A HELICOPTER

- 1 SONAR DOME
- 2 SONAR EQUIPMENT
- 3 DECKING RECOVERED WITH FORWARD SONAR TRACK
- 4 FIRST AID KITS

- 5 BROOM CLOSET DOOR
- 6 SONAR TRACK
